PROJECT : TE1

Size	Document Number DDR SO-DIMM(200P)	Rev 1A
Date:	Wednesday, January 23, 2008	Sheet 13 of 41

PROJECT : BU2/B01
Quanta Computer Inc.

Size	Document Number	Rev
	VT1 1.05V (RT8202)	1D
Date:	Wednesday, January 23, 2008	Sheet 34 of 41

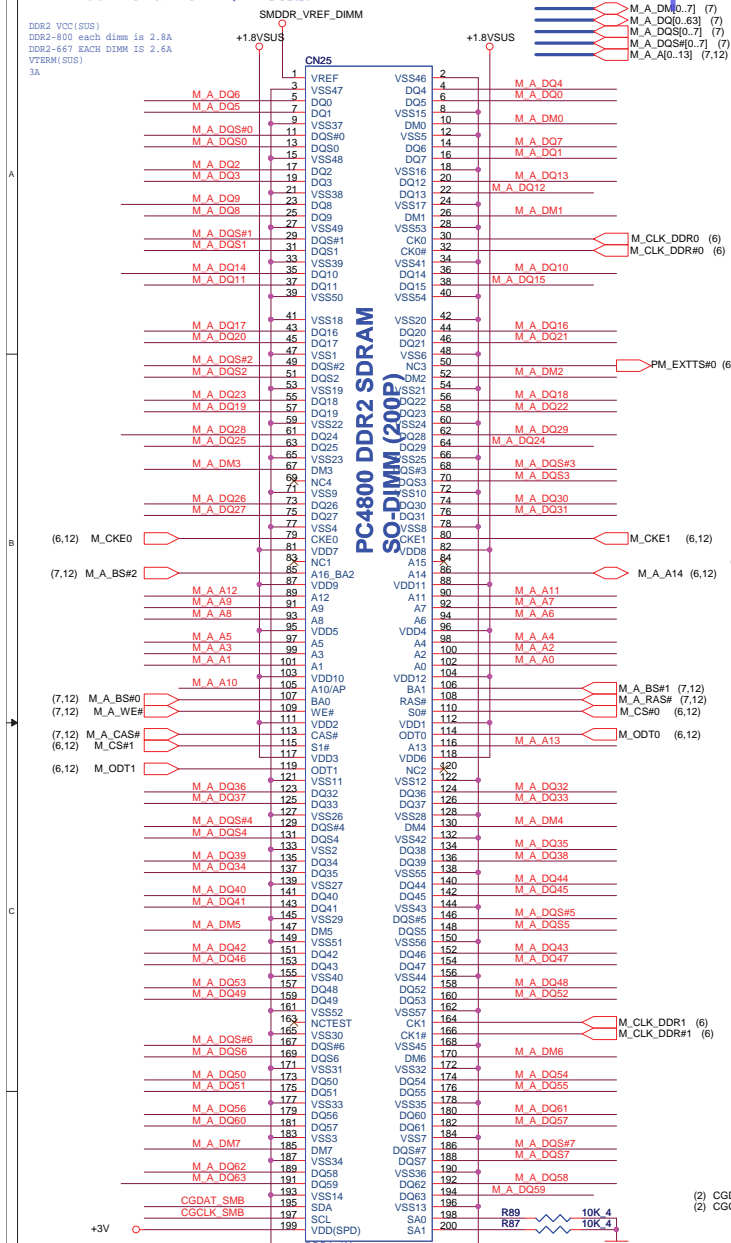
H: 6mm

CLOCK 0,1
CKE 0,1

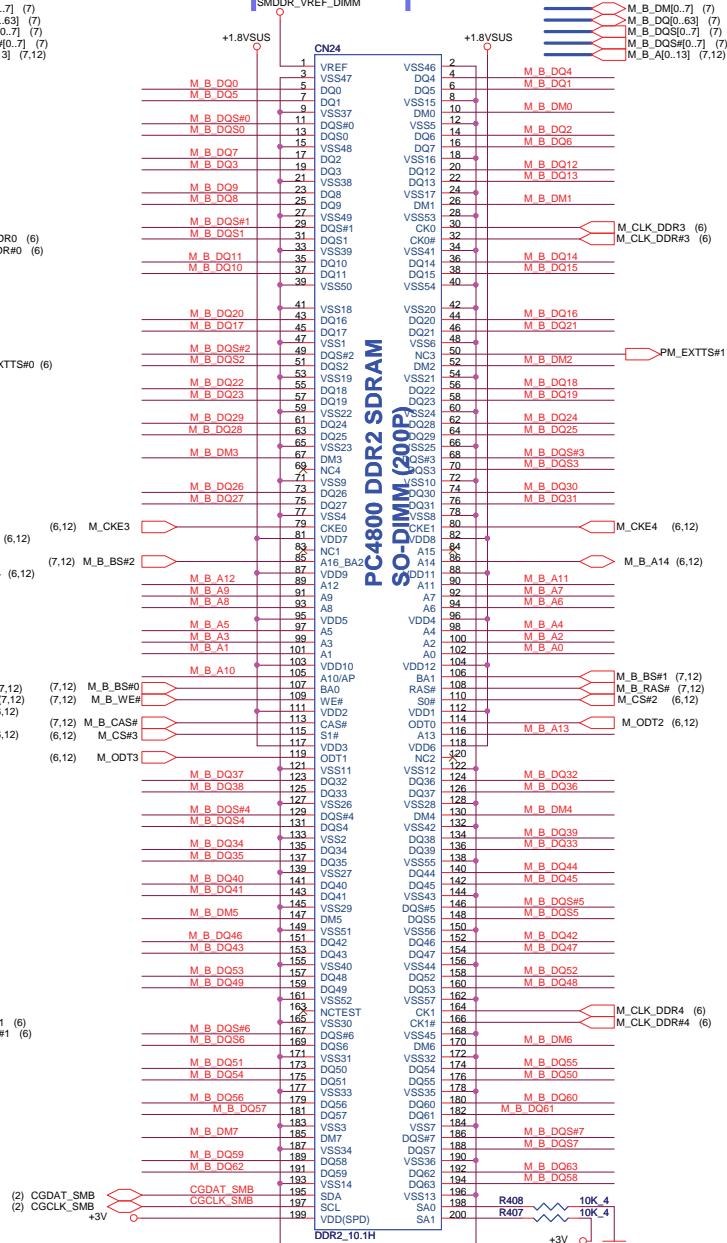
H: 10.1mm

CLOCK 3,4
CKE 2,3
