LKB-ADDs, Plus Schematic

DDQ12/LA1901 Schematic with Capture CIS and Function field
uFCPGA Banias
01-02-2004
REV: 3.0

Title Index and Config

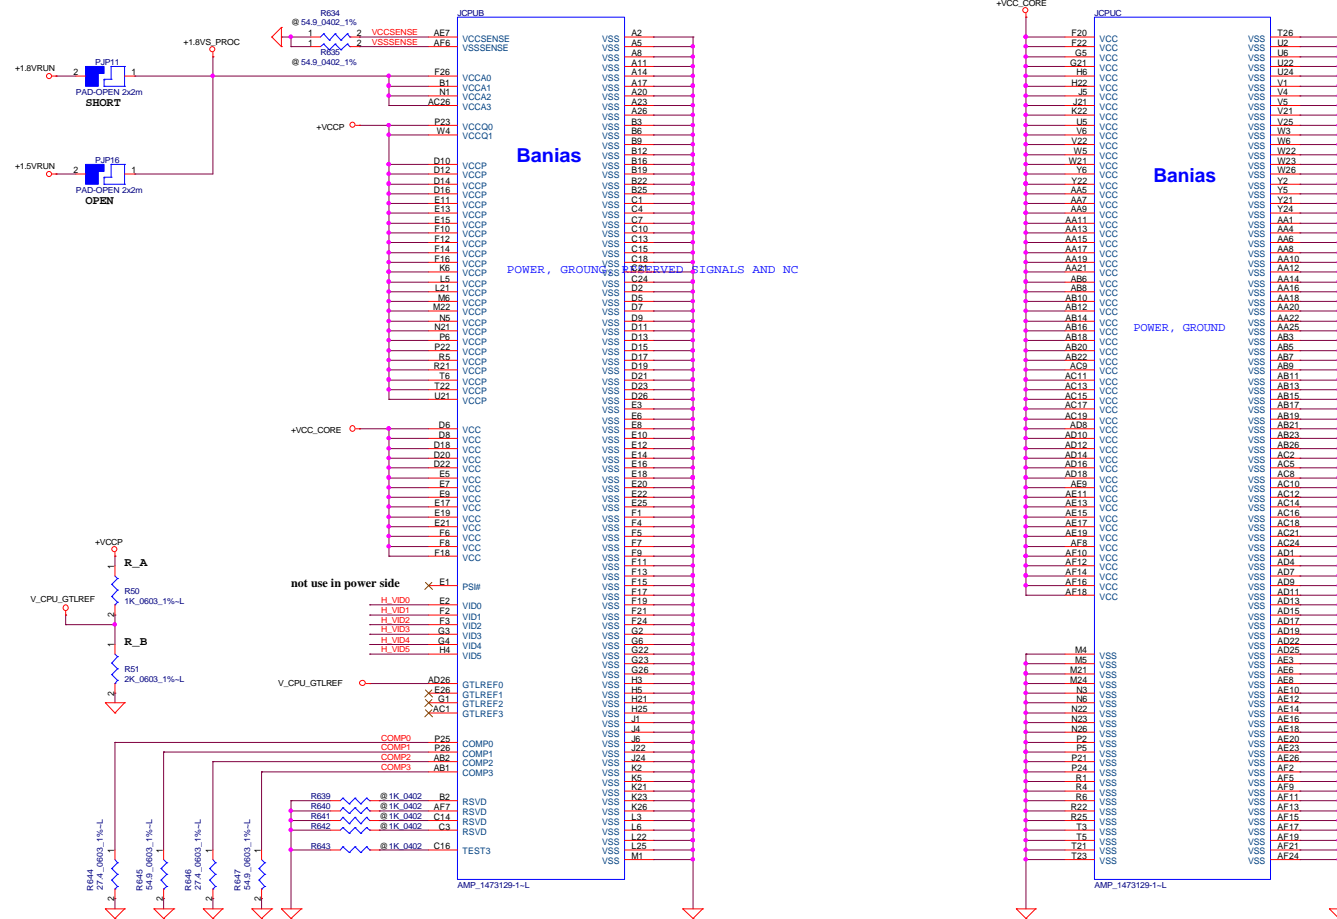
CPU Voltage ID

Resistor placed within
0.5" of CPU pin.Trace
should be at least 25
mils away from any
other toggling signal.

For test only ,Cmos output

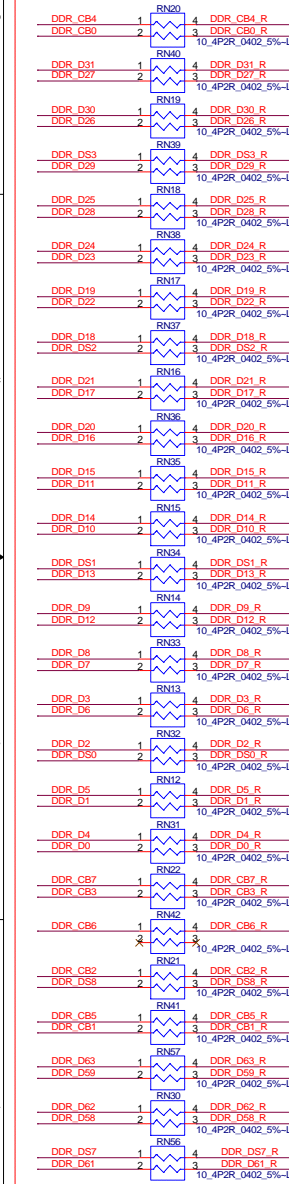
Layout Note:
 Place these resistor
 closely DIMM0,all
 trace length<750 mil

Layout Note:
 Place these resistor
 closely DIMM0,all
 trace length
 Max=1.3"

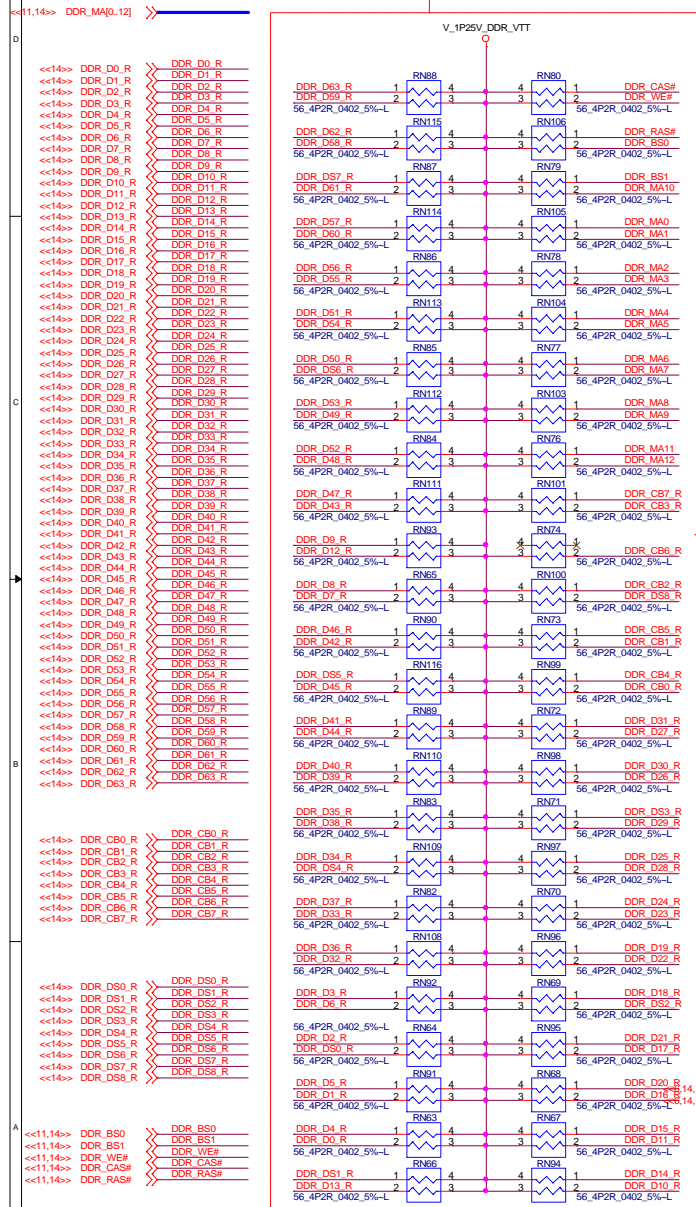
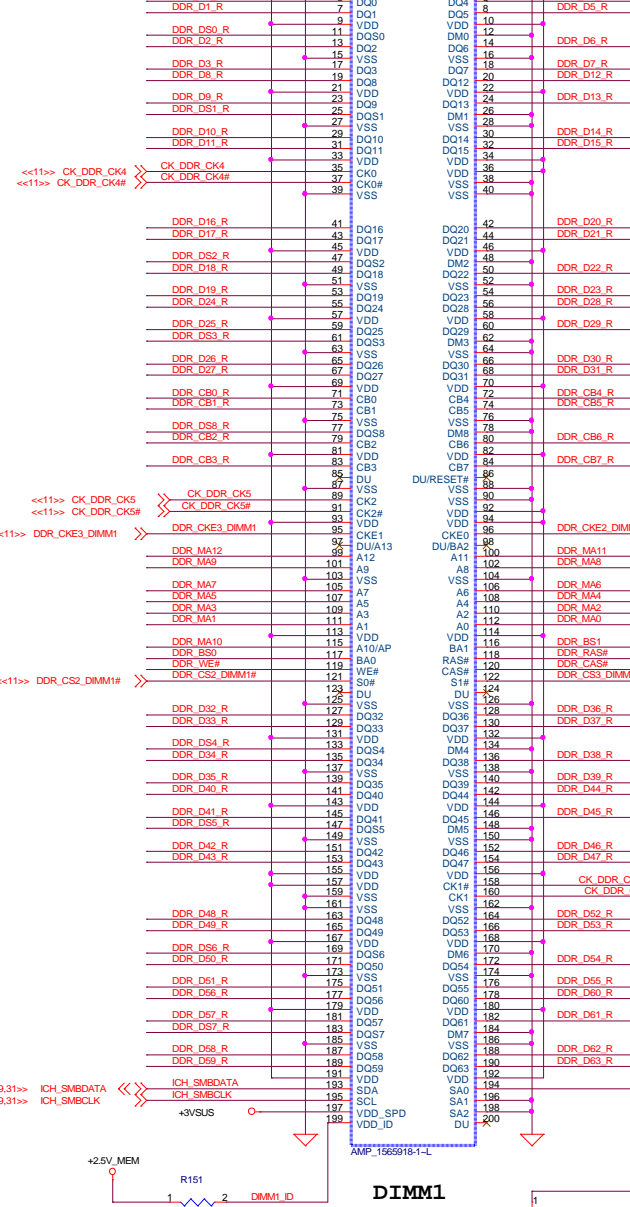
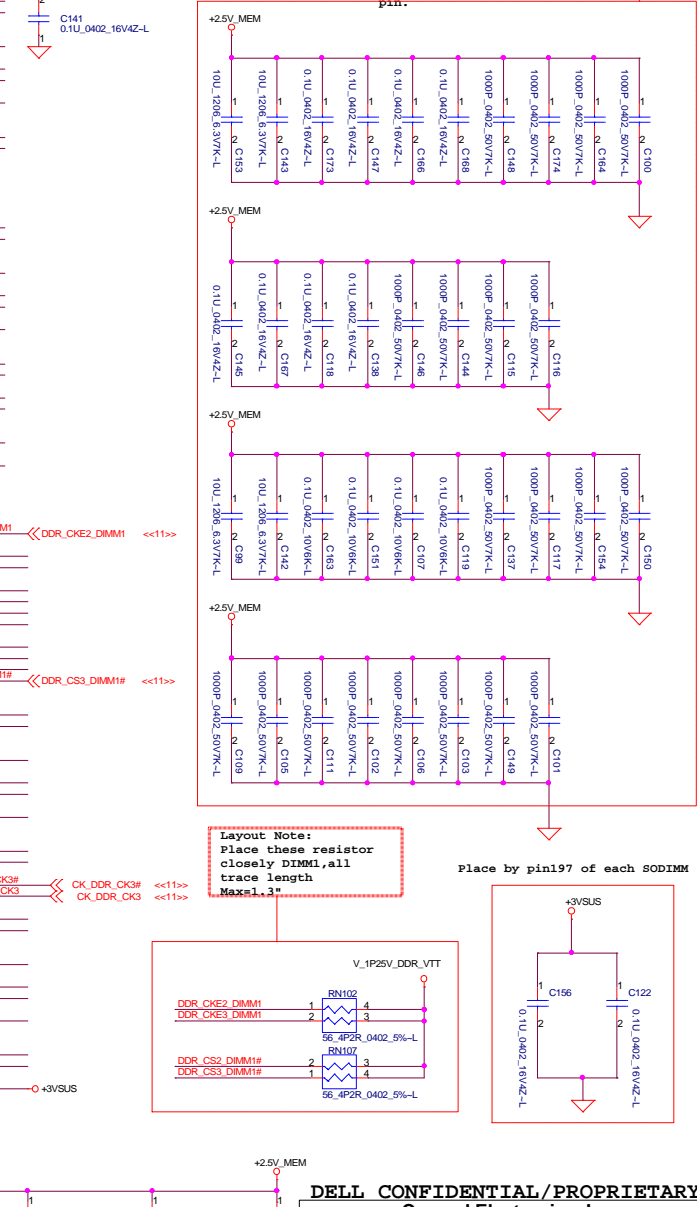
One .1uF cap per power pin.
Place each cap close to
pin.

Layout Note:
Place these resistor
closely DIMM1,all
trace length
Max<=1.3"

Place by pin197 of each SODIMM

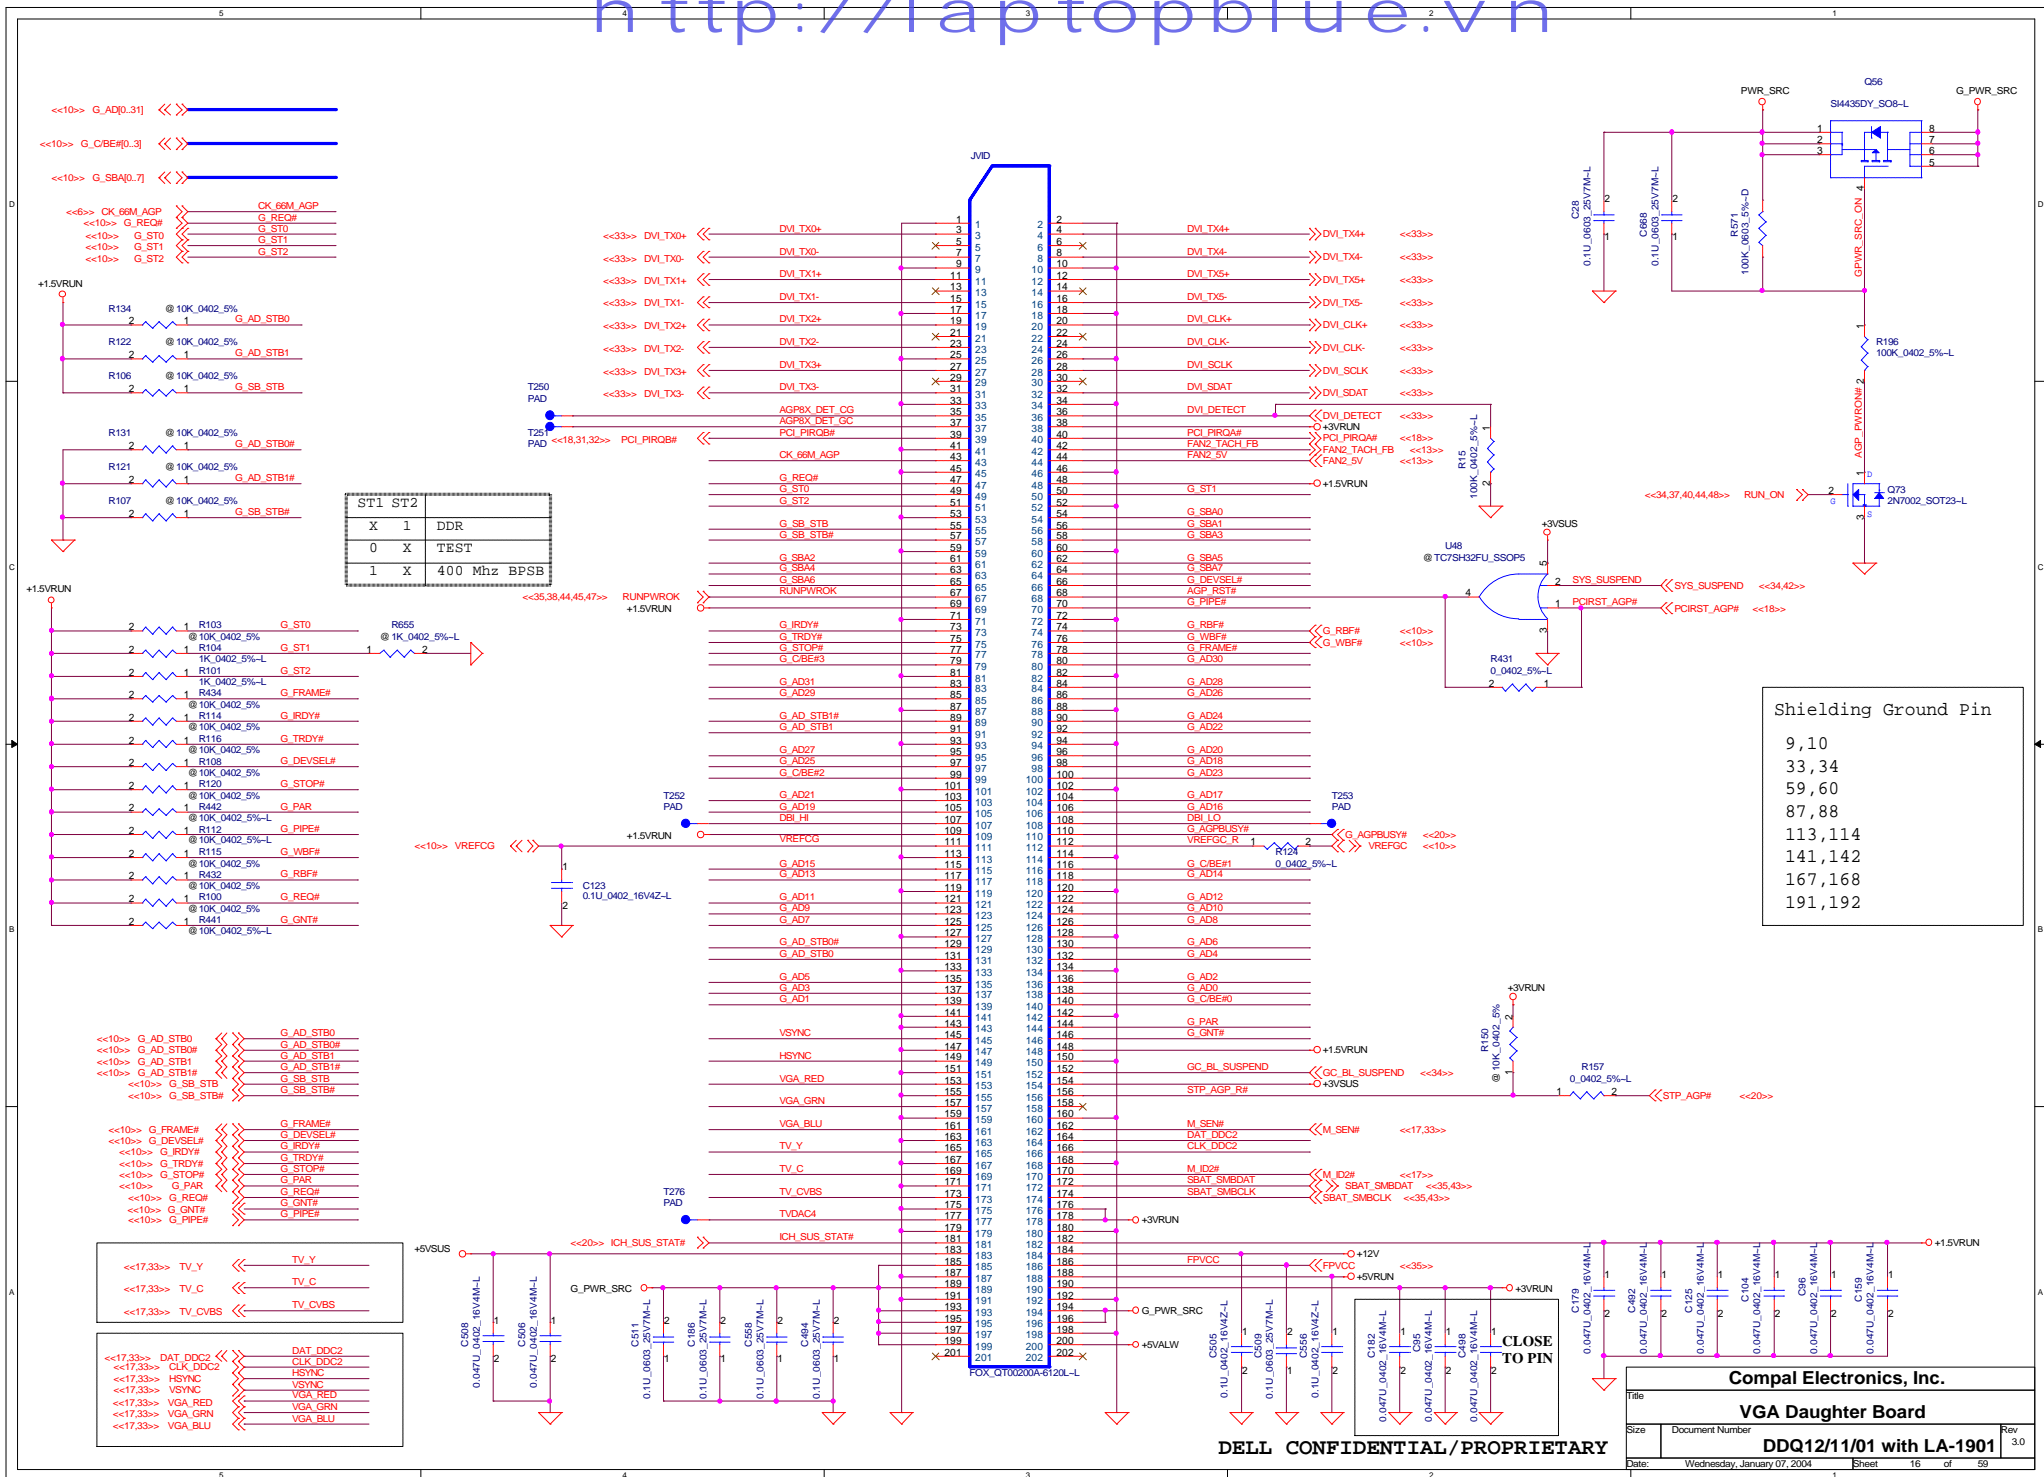
VGA Daughter Board

Shielding Ground Pin

9,10
33,34
59,60
87,88
113,114
141,142
167,168
191,192

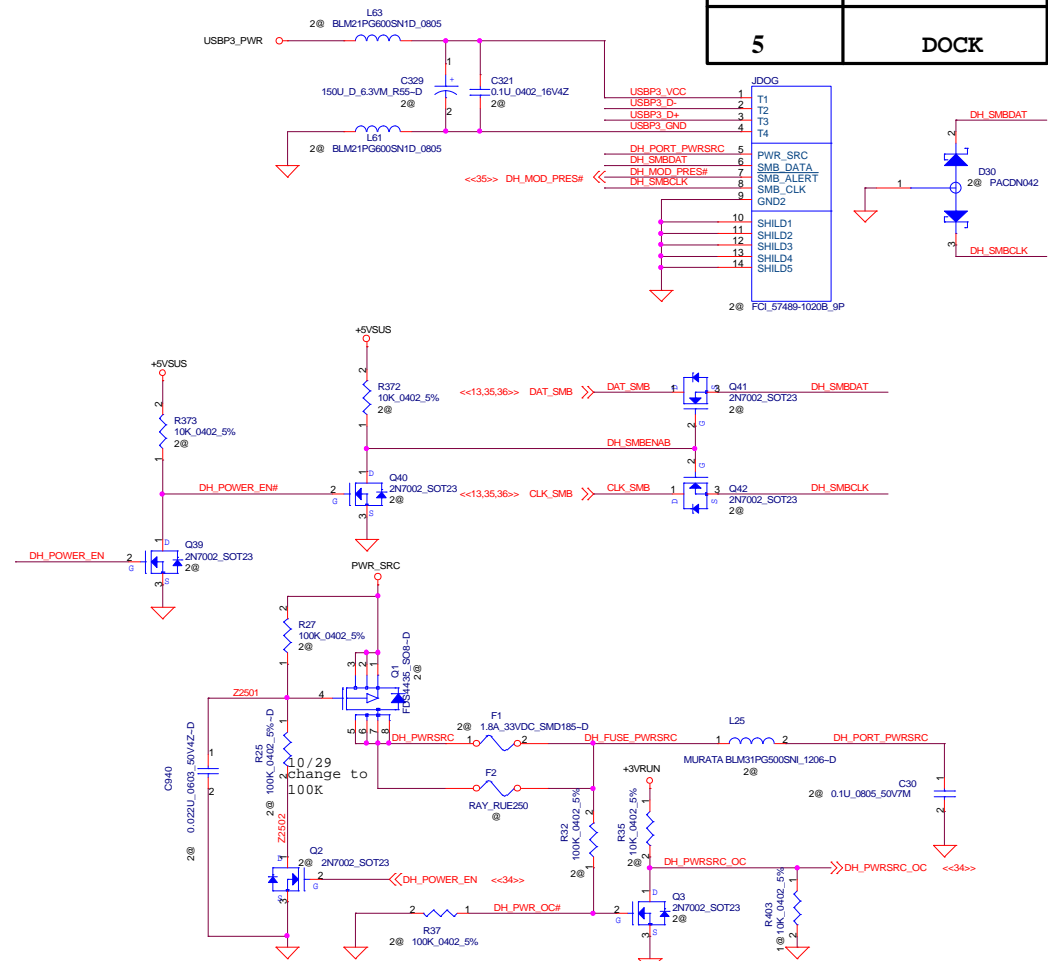
Title			
USB 2.0			
Size	Document Number	Rev	
	DDQ12/11/01 with LA-1901	3.0	
Date:	Wednesday, January 07, 2004	Sheet	25 of 59

USB PORT#	DESTINATION
0	BACK
1	BT
2	BACK
3	DOG
4	MOD
5	DOCK

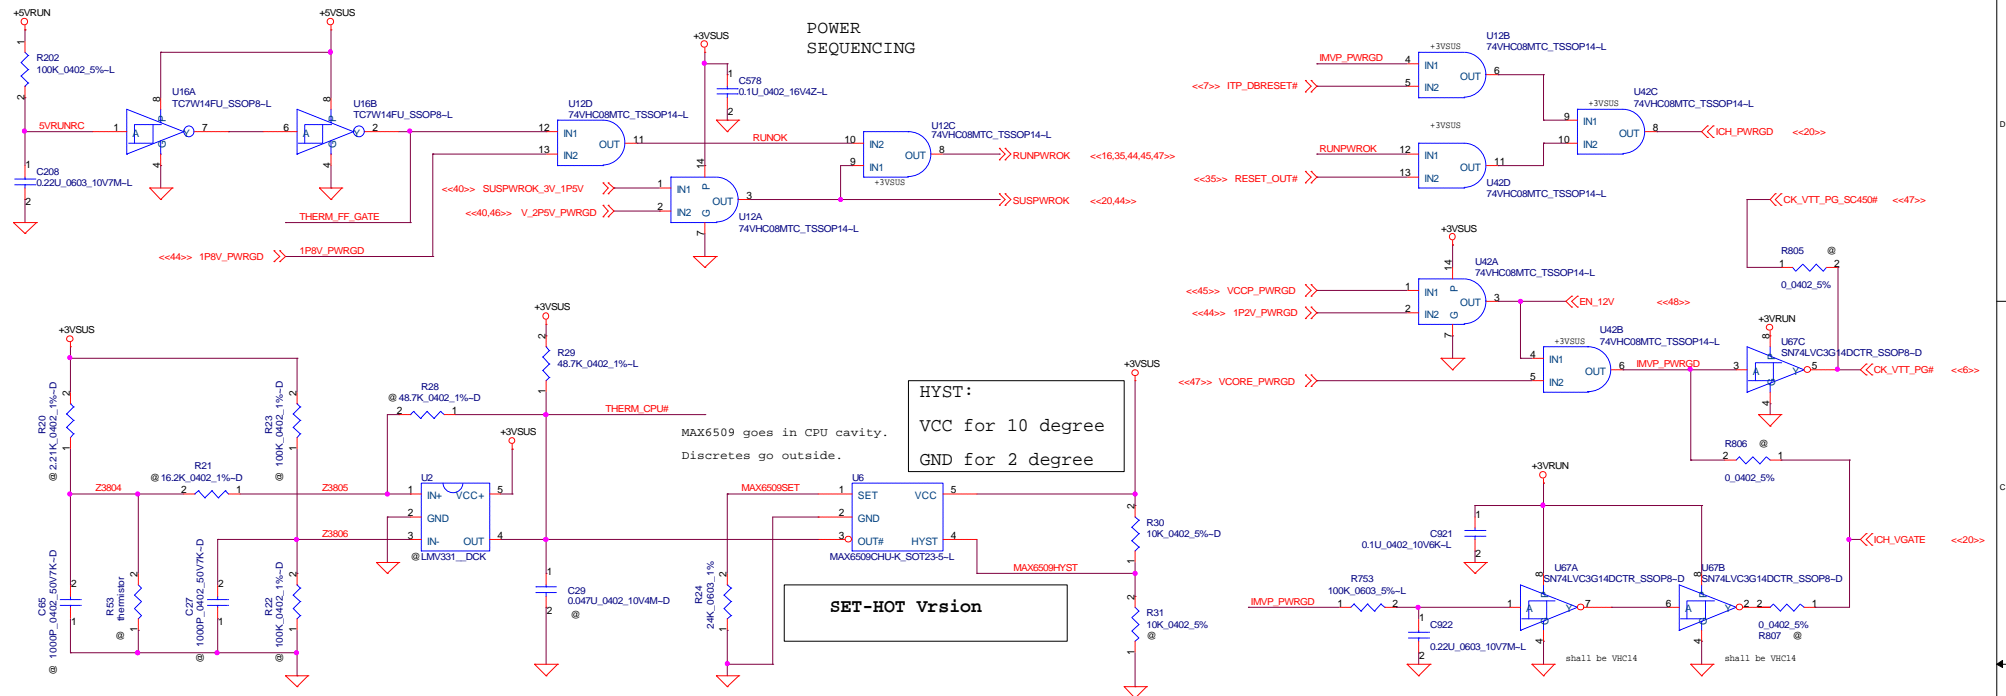
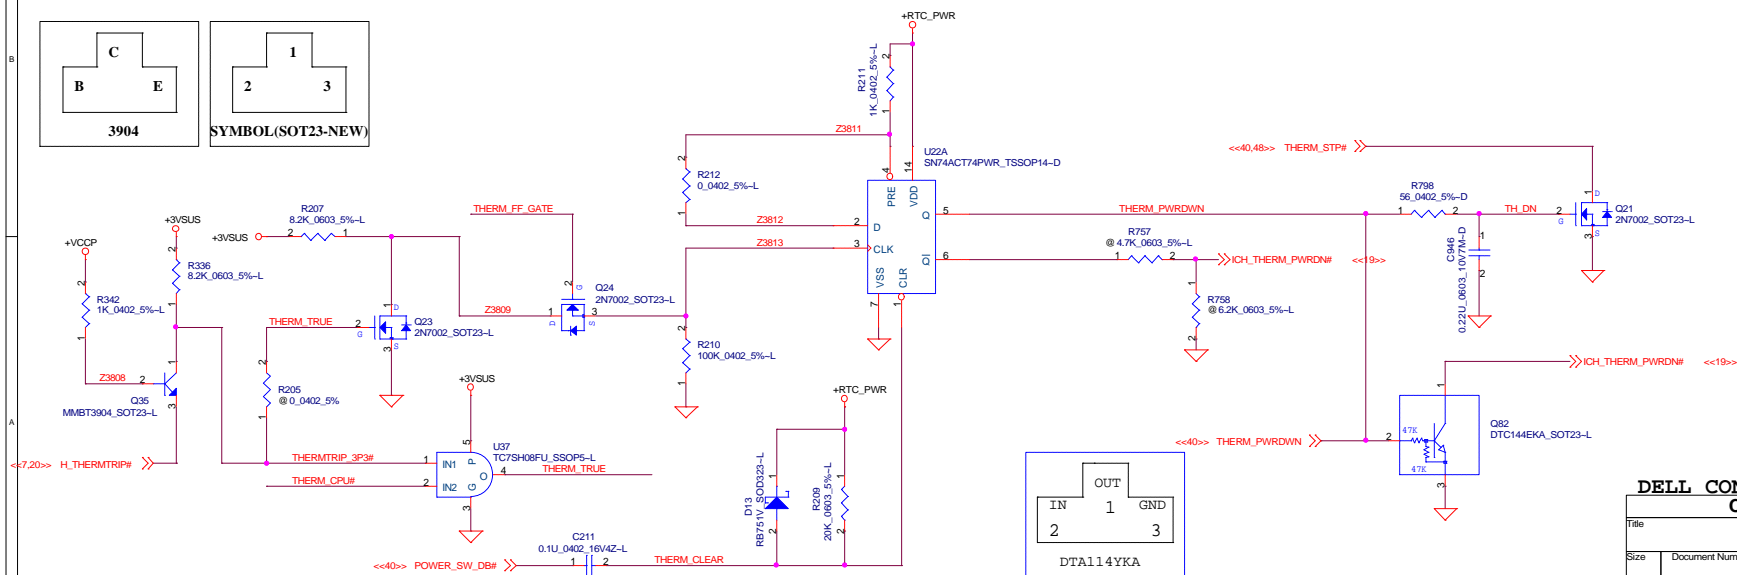
IR,PS2,RTC

Thermistor goes in CPU cavity.

Dell P/N 8K573

Semitech P/N 103KT2125-1P

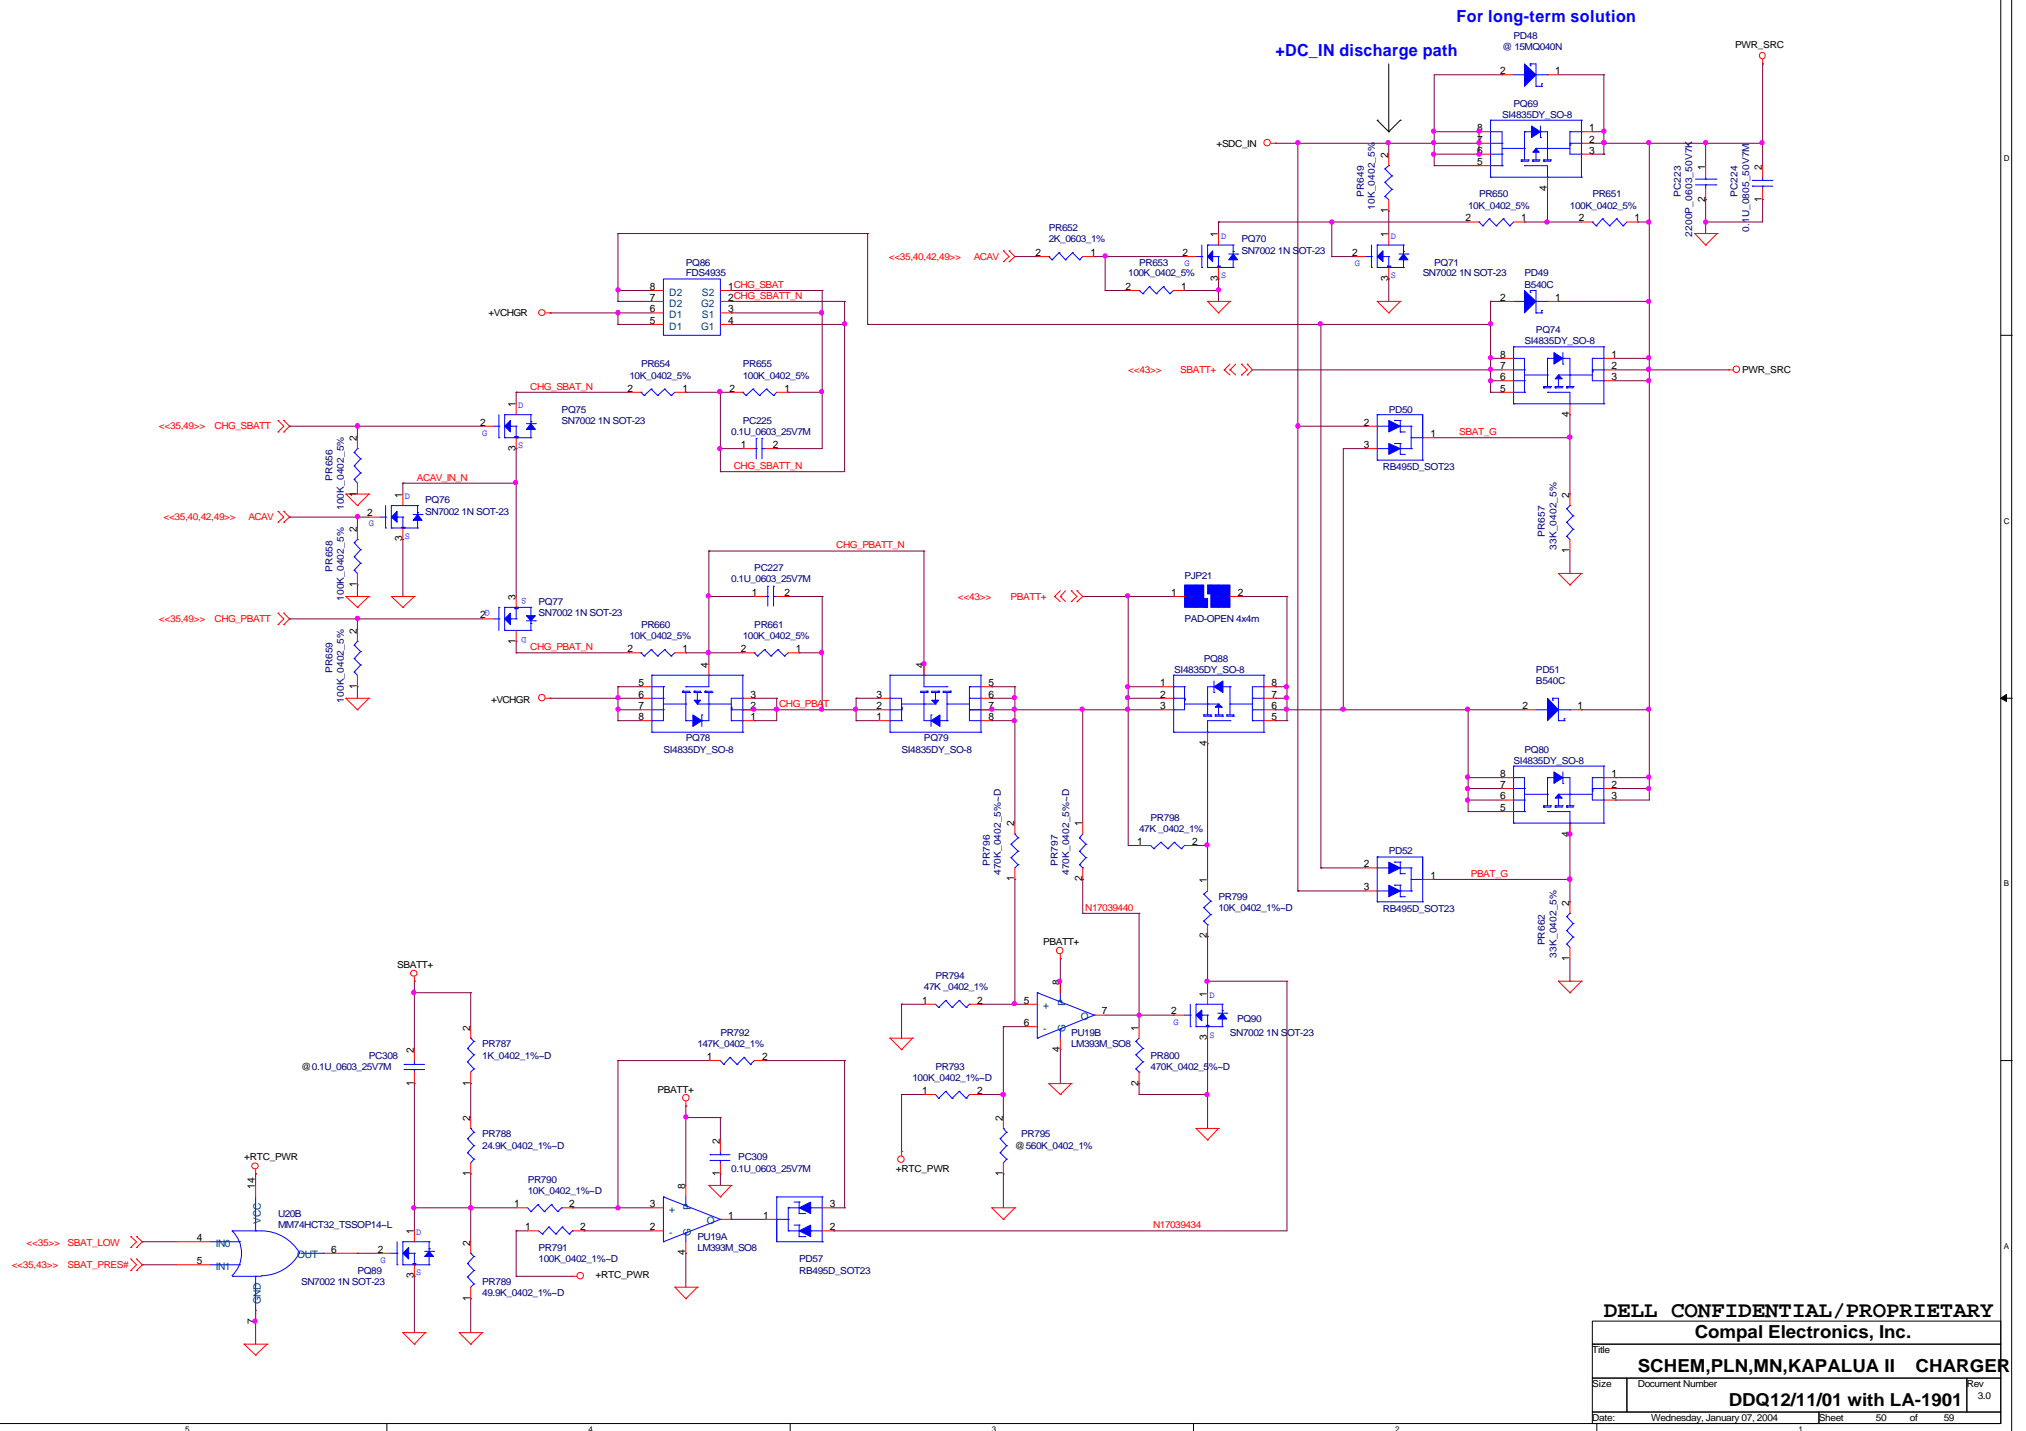
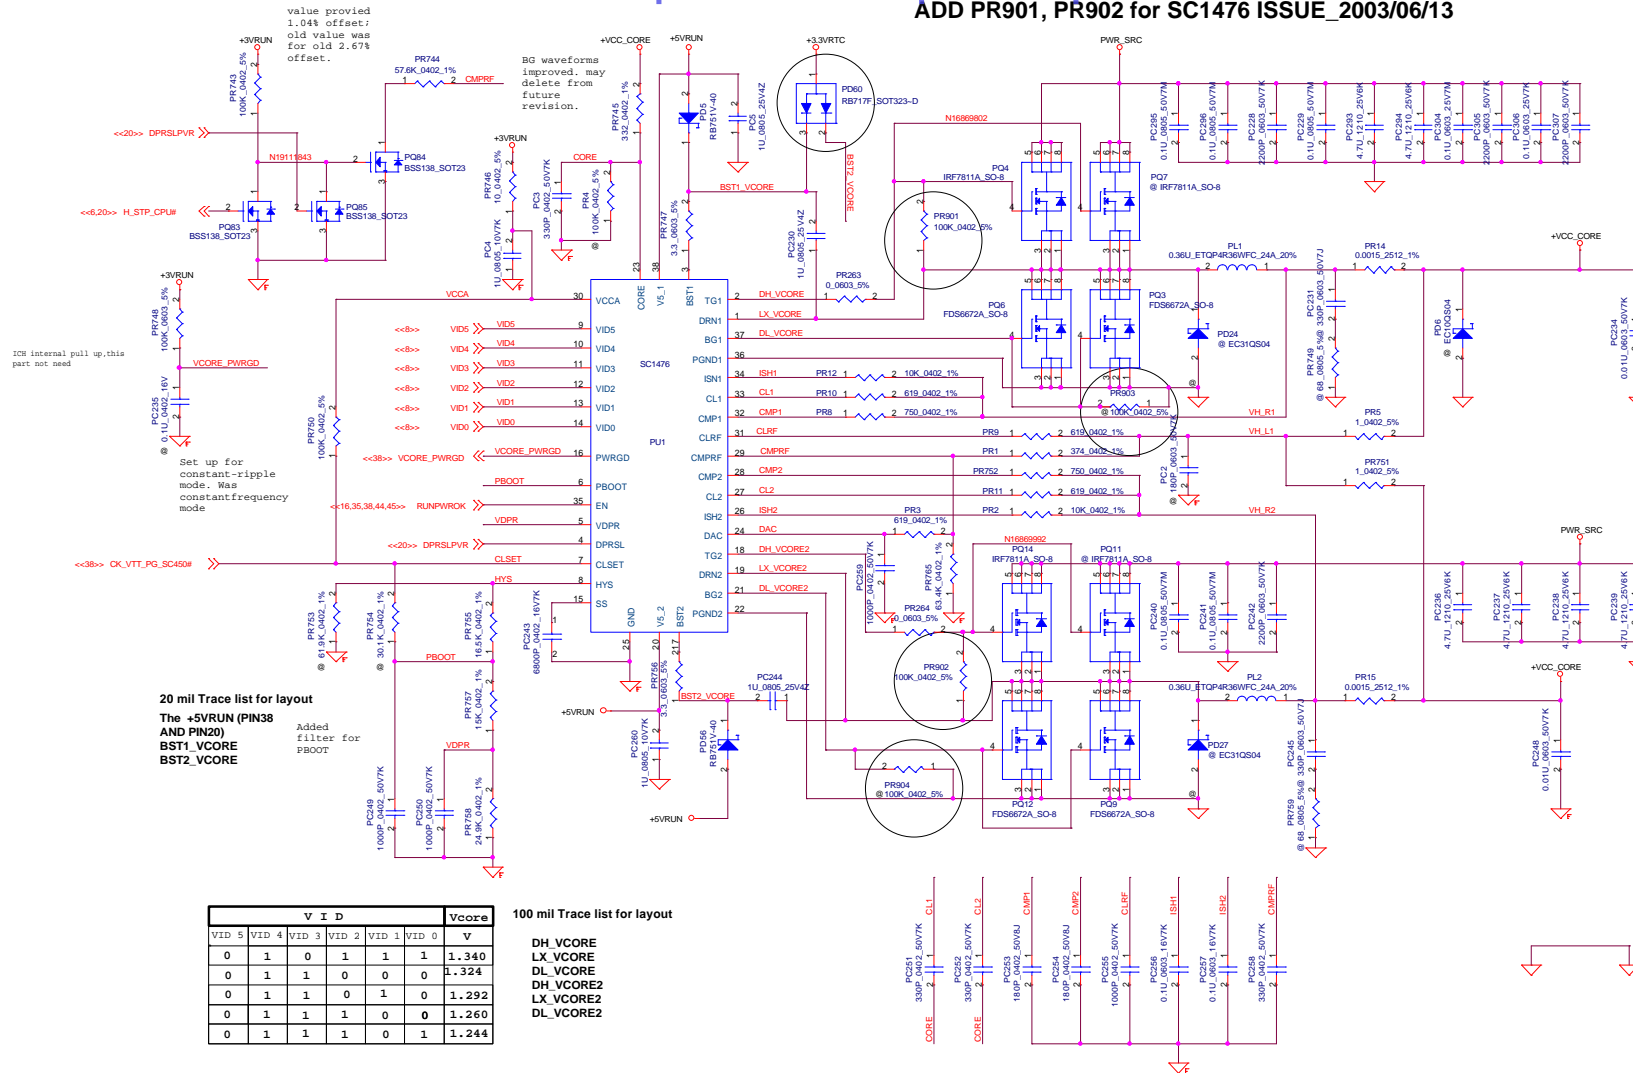
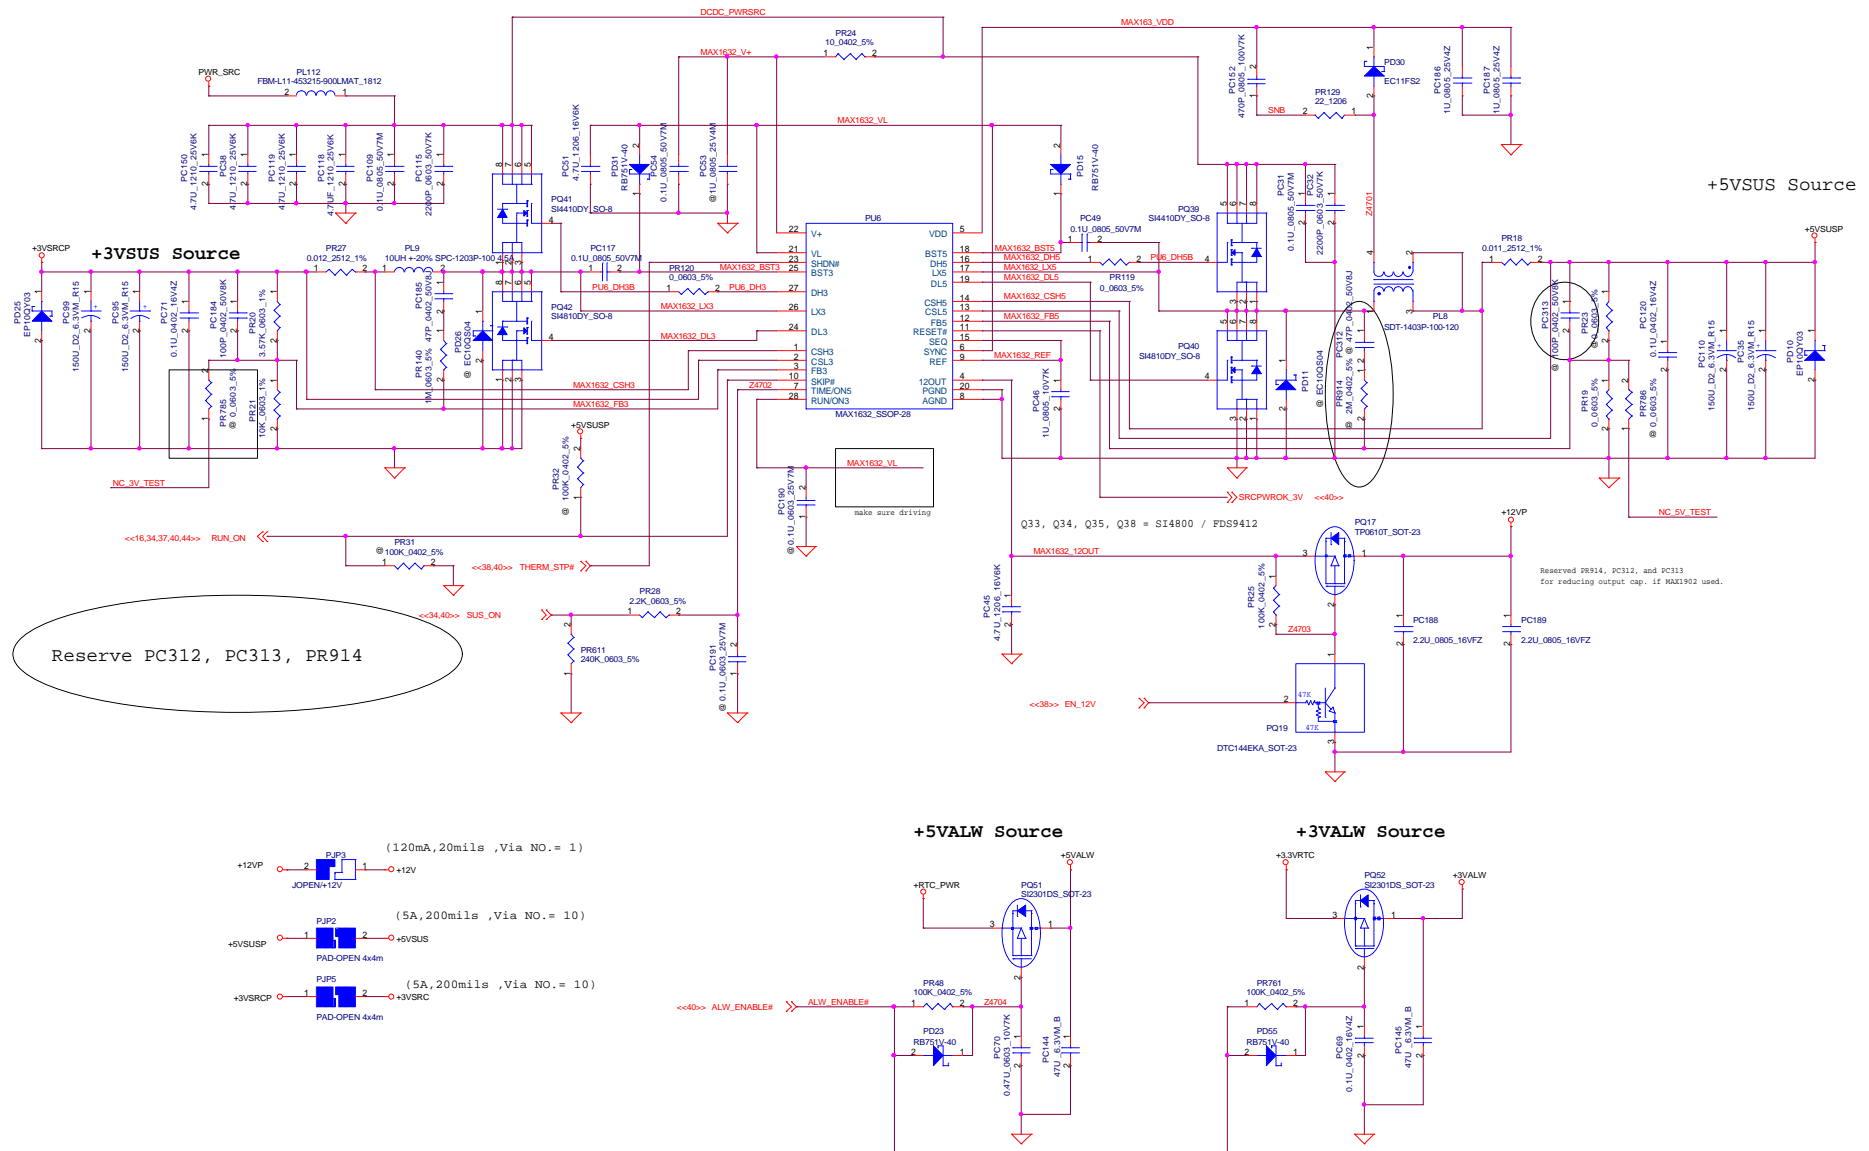
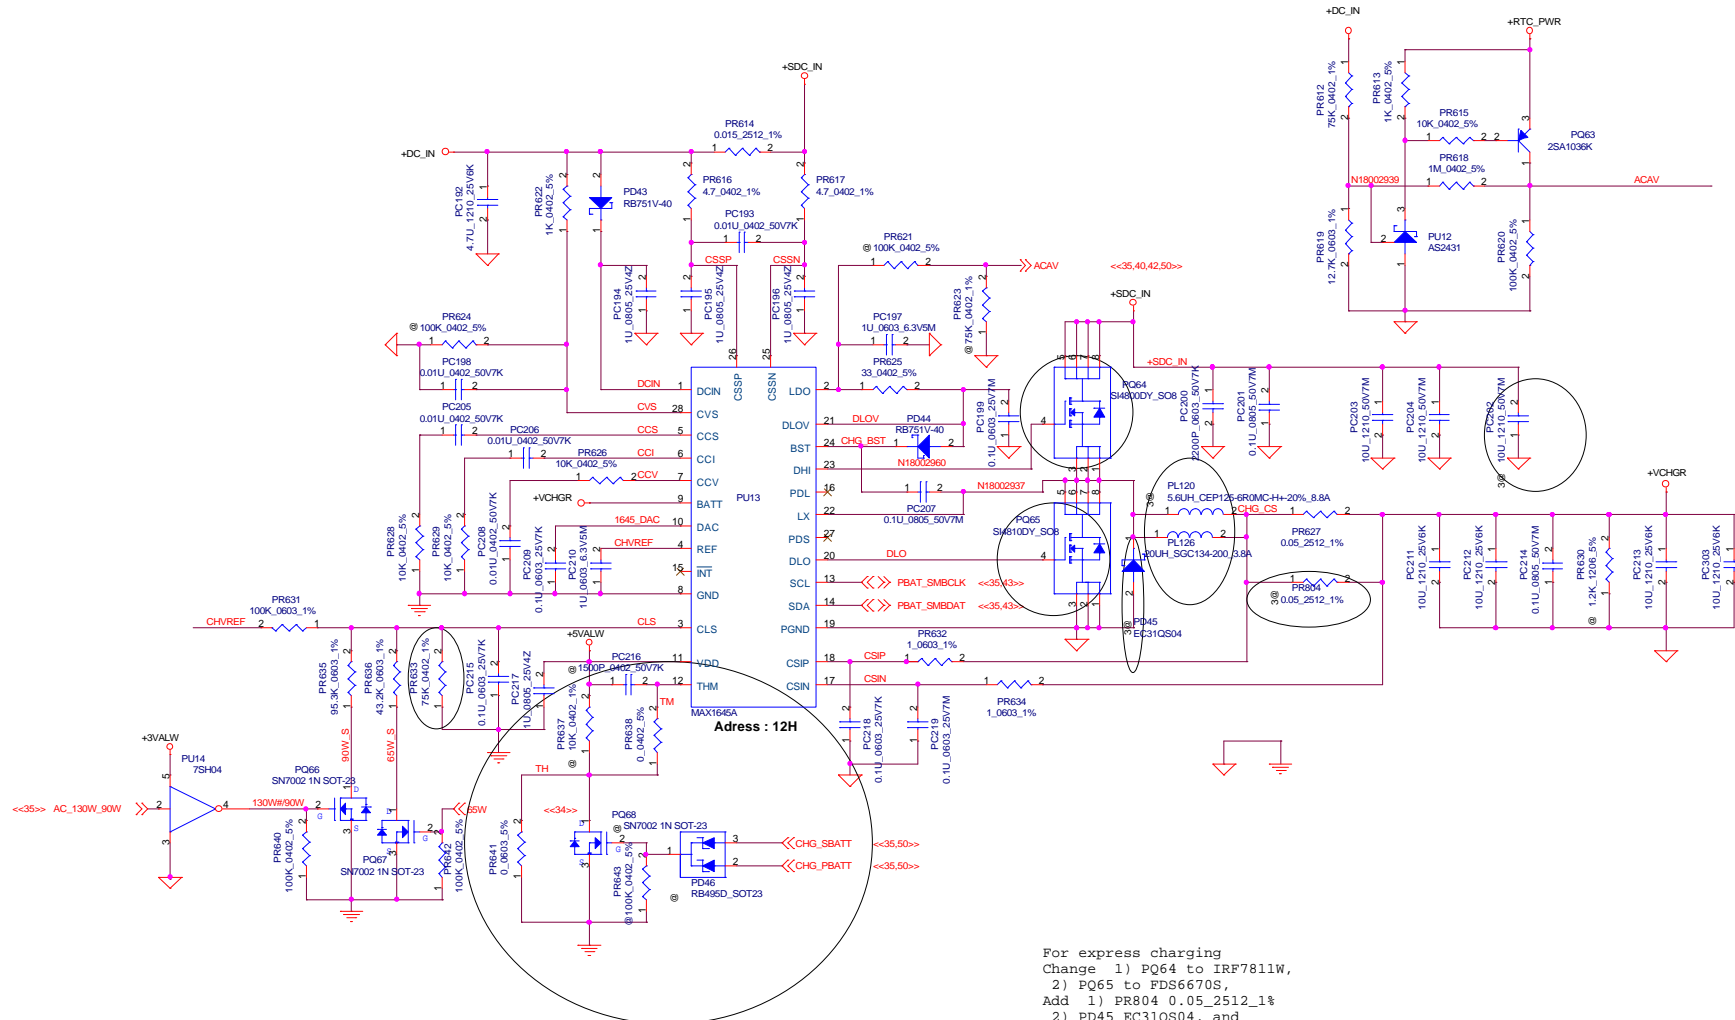
DELL CONFIDENTIAL / PROPRIETARY			
Compal Electronics, Inc.			
Title SCHEM,PLN,MN,KAPALUA II CHARGER			
Size	Document Number	Rev	
	DDQ12/1/01 with LA-1901	3.0	
Date:	Wednesday, January 07, 2004		
	Sheet	50	of 50

If use 65W adapter on Lindbergh Plus only then PR633 need change from 75K to 27K for safe.
and delpop PR635, PR636, PU14, PQ66, PR640, PQ67, PR642

65W (2.93A)	90W (4.0A)	130W (5.85A)
65W	H	L	L
AC_130W_90W	H	L	H

For express charging
Change 1) PQ64 to IRF7811W,
2) PQ65 to FDS6670S,
Add 1) PR804 0.05_2512_1%
2) PD45 EC31QS04, and
3) PC202 10uF_1210_50V7
4) PL120 to 5.6uH_CEP125-6R0MC-H+-20%_8.8A
Delete PL126

35	43	Battery Conn.	03/05/2003	Dell	To Use Common Part as Bondi (Change PN to DC04001440L)	JSBAT	A00
36	49	Charger	03/05/2003	Compal	To Reduce RTC Bridge Battery Leakage Current (Changed Power Plane from +RTC_PWR to +5VALW)	PU13. PC216, PR637, PC217, Depop PR641	A01
37	42	Power DC-IN	04/07/2003	Dell	Reserve zero ohm bypass resistor for Rbatt fuse	Adding PR850(@)	X00
38	42	Power DC-IN	04/07/2003	Dell	Fuse PFS2 Removed and Diode PD3 Shorted. The RBAT Blow Up (200 deg F). POP the Fuse instead of the 0ohm resistor.	Pop PFS2 Depop PR850	X00
39	45	1.5V / 1.05V	04/23/2003	Dell	Increased OCP for S3 Issue. (3300 to 7320)	PR727	X00
40	47	Vcc_core	06/13/2003	Dell	CPU_core PWM SC1476 IC issue	Adding PR901, PR902 to 100K, PR903(@) PR904(@)	A00
41	47	Vcc_core	07/29/2003	Dell	PWM SC1476 Chip issue solution for First system on	Adding PD60	A01
42	47	Vcc_core	10/15/2003	Compal	SC1476 chip update to R6 Version for fixed First start-up issue	Change PU1 to R6 Version chip, and delete PD60 diode	A01
