# Kapalua Schematic

BDQ11/LA1601 Schematic with Capture CIS and Function field  
uFCPGA Banias  
02-12-2003  
REV: 0.5

Title		
Cover Sheet		
Size	Document Number	Rev
	BDQ11/LA-1601	0.5
Date:	星期三, 二月 12, 2003	Sheet 1 of 56

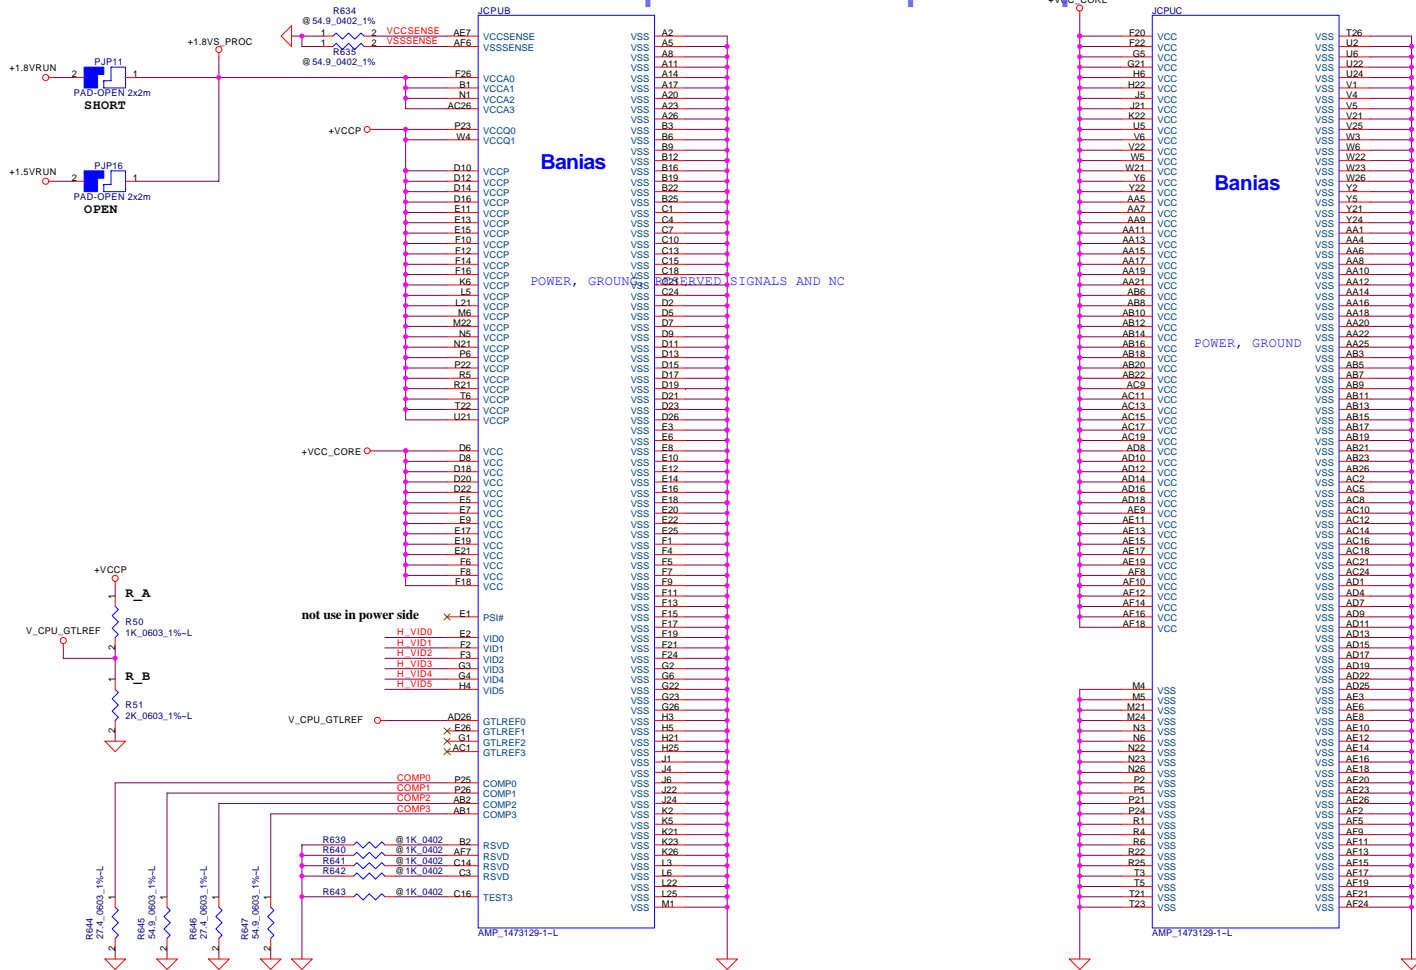
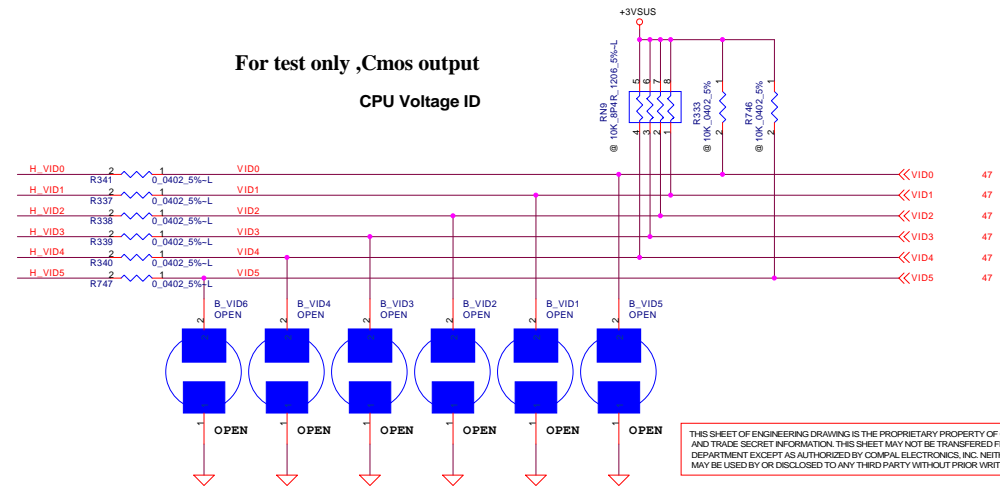
Title		Banias Processor in mFCPGA479	
Size	Document Number	BDQ11/LA-1601	
C			Rev 0.5
Date:	星期二, 三月 06, 2003	Sheet	8 of 56

For test only ,Cmos output  
CPU Voltage ID

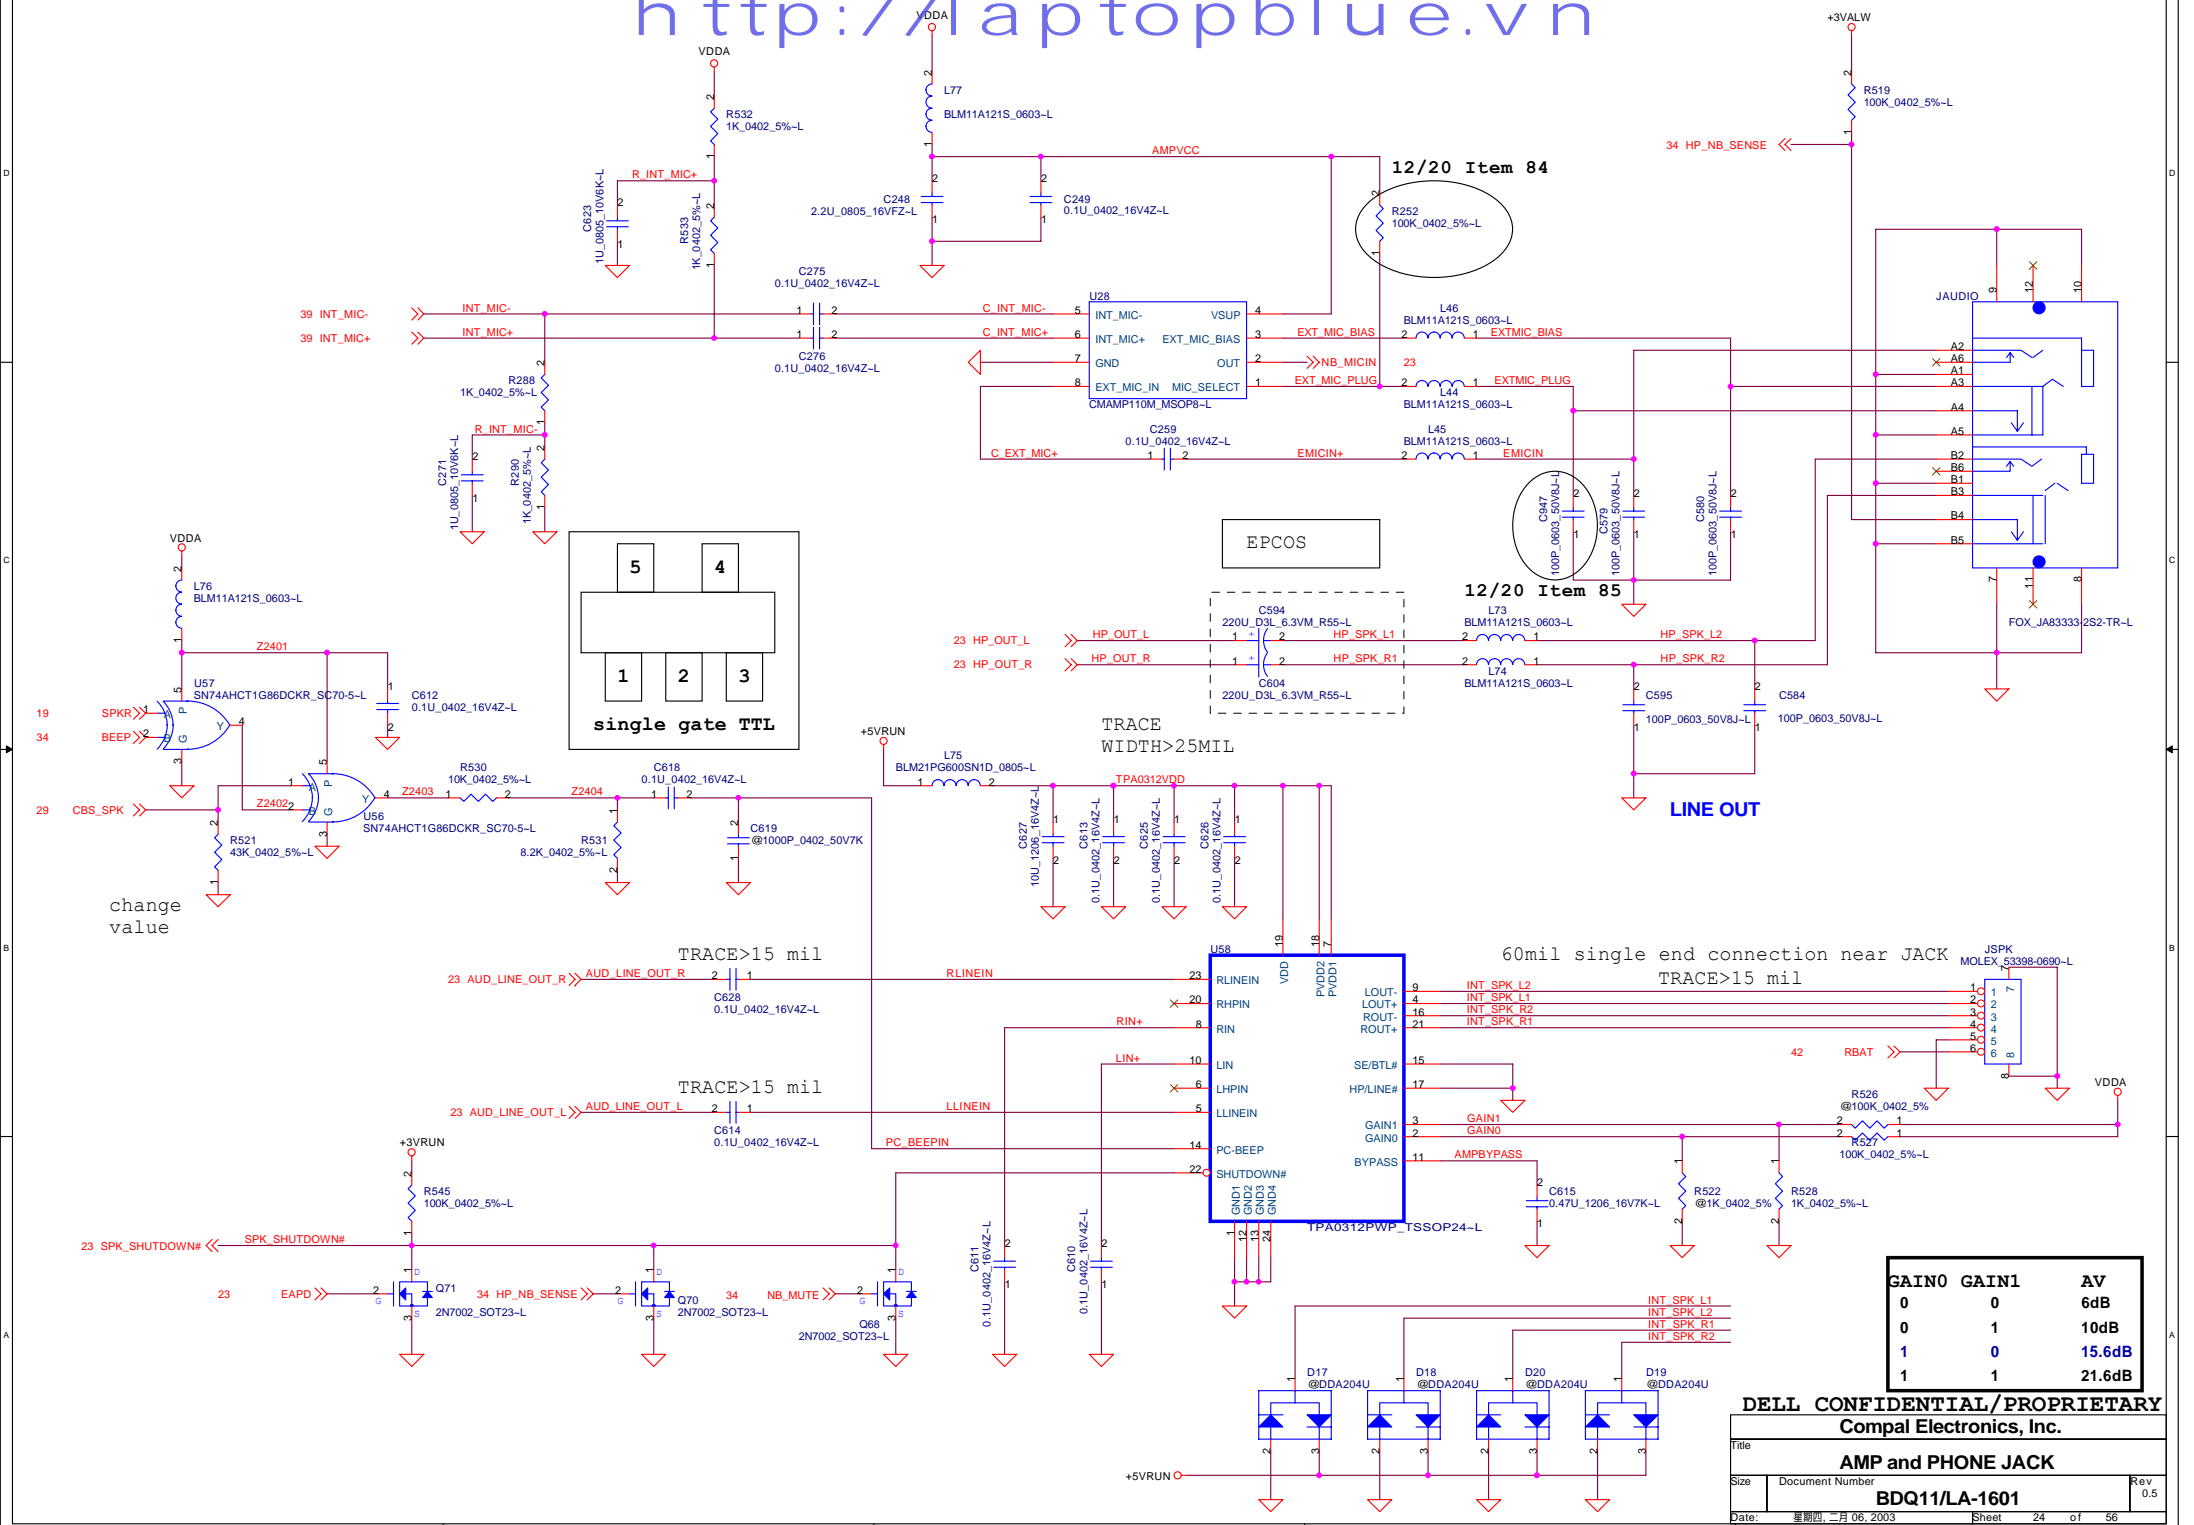
Title			
AMP and PHONE JACK			
Size	Document Number		Rev
	BDQ11/LA-1601		0.5
Date:	星期日 一月 06 2003		Sheet 24 of 56

GAIN0	GAIN1	AV
0	0	6dB
0	1	10dB
1	0	15.6dB
1	1	21.6dB

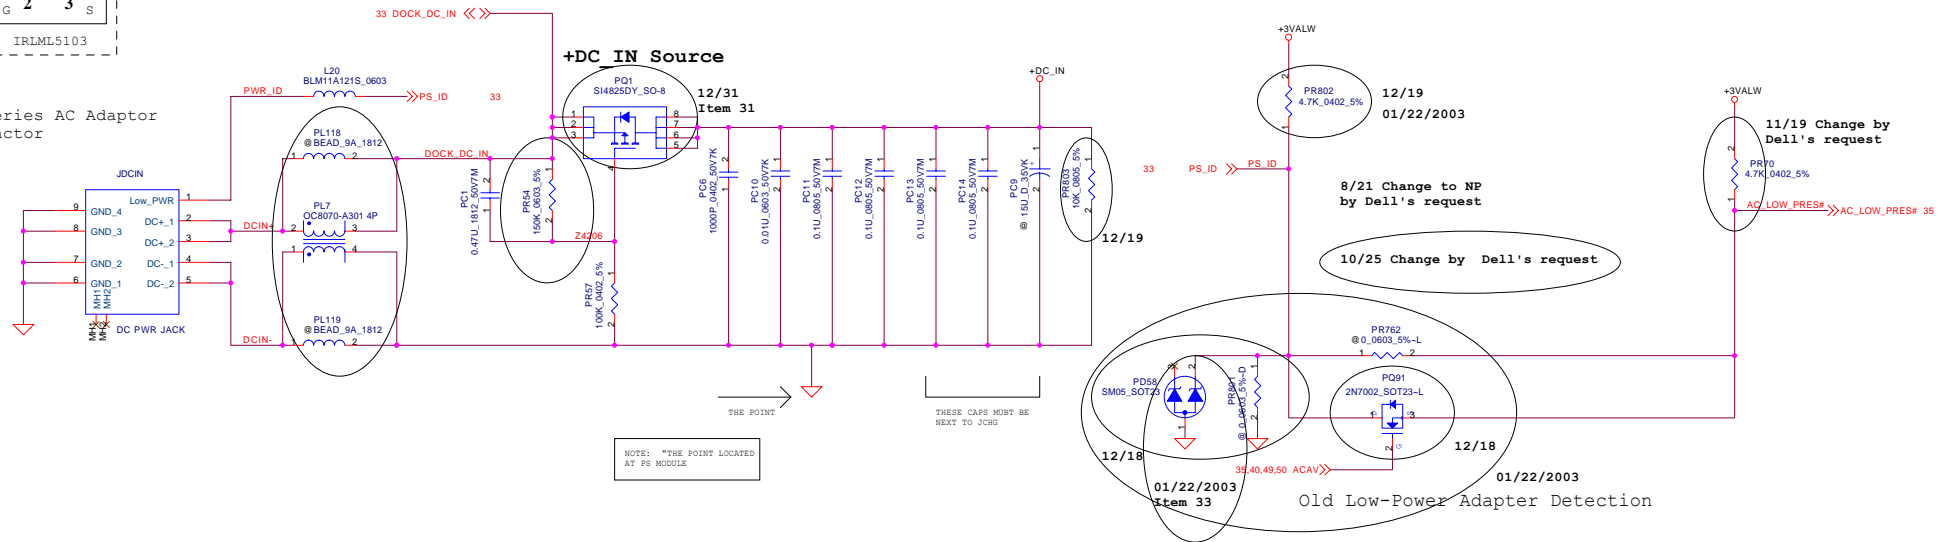
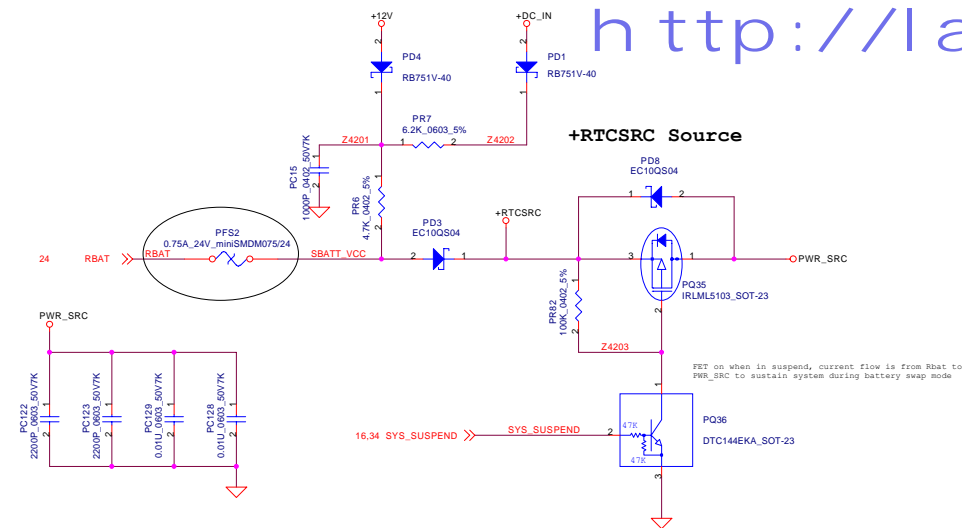
Title			
DC-IN			
Size	Document Number	Rev	
	BDQ11/LA-1601	0.5	
Date:	星期四, 三月 06, 2003	Sheet	42 of 56

Z-series AC Adaptor  
Connctor

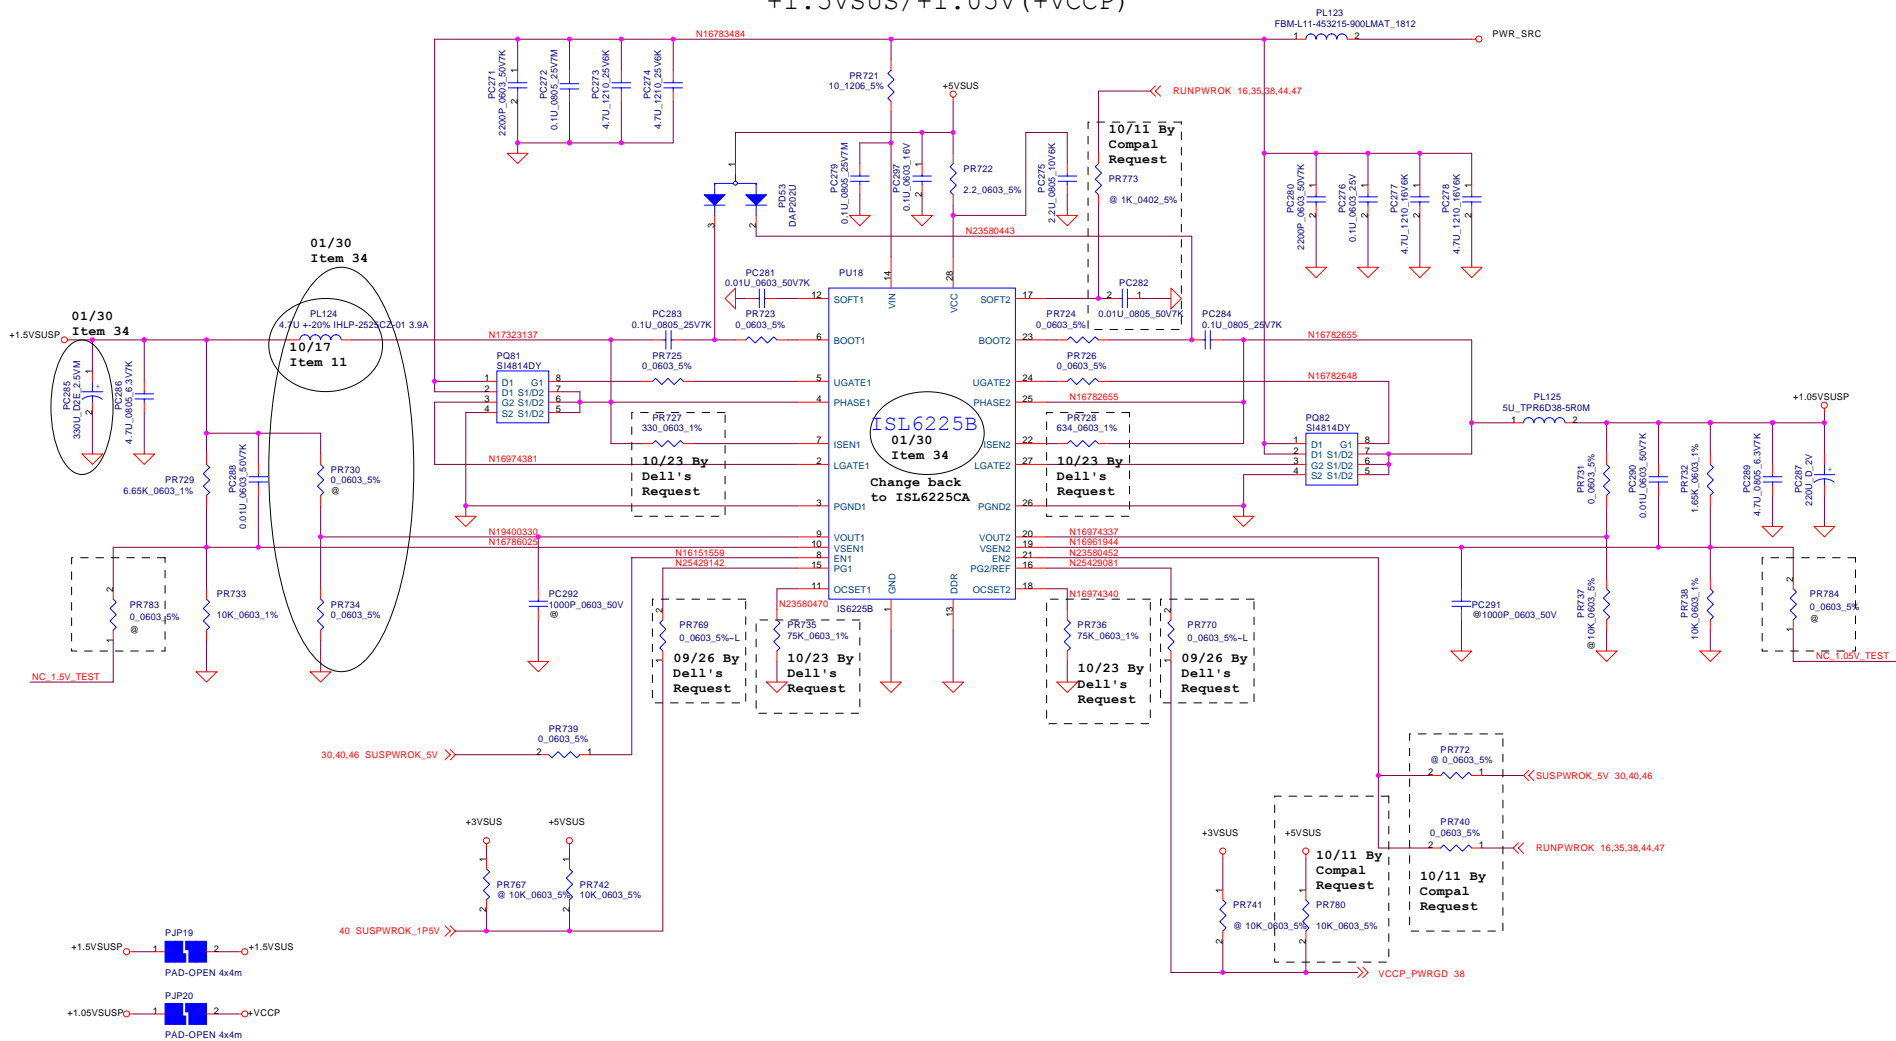
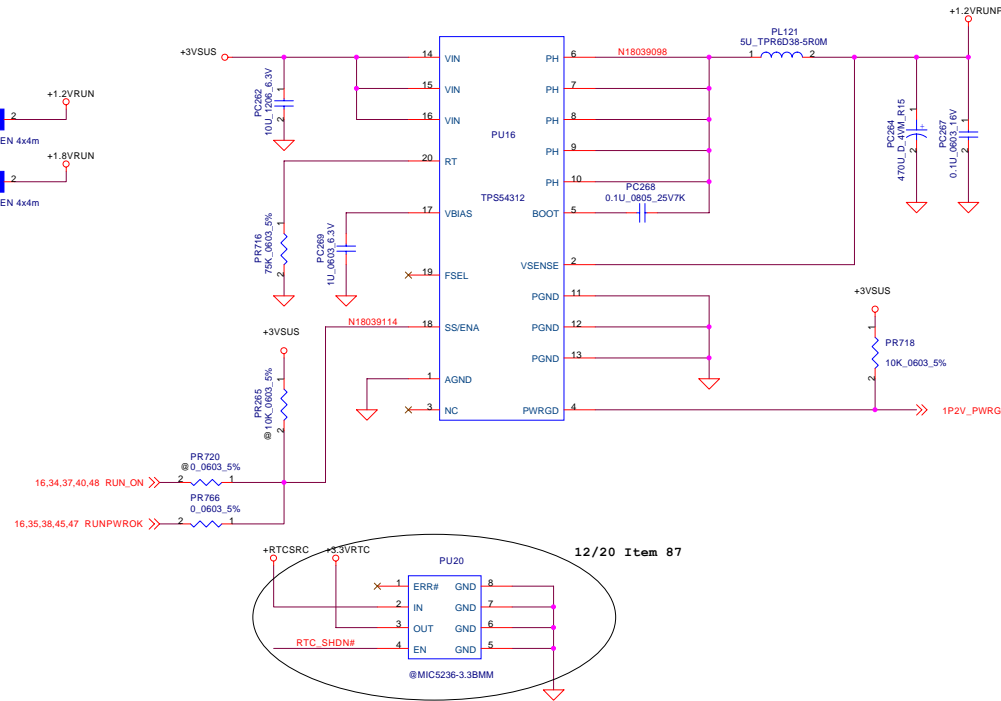
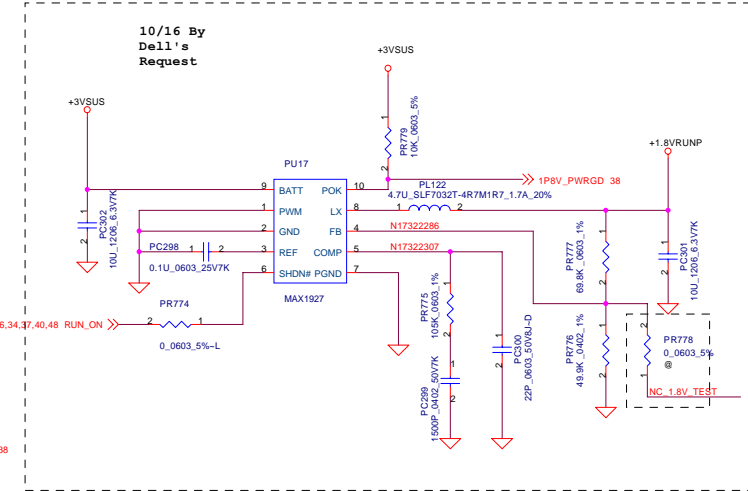
Title			
<b>+1.5V &amp; +1.05V</b>			
Size	Document Number		Rev
	<b>BDQ11/LA-1601</b>		<b>0.5</b>
Date:	星期四, 三月 06, 2003	Sheet	45 of 56

Allows SUS planes to power ALW planes when possible

+1.5VSUS/+1.05V (+VCCP)

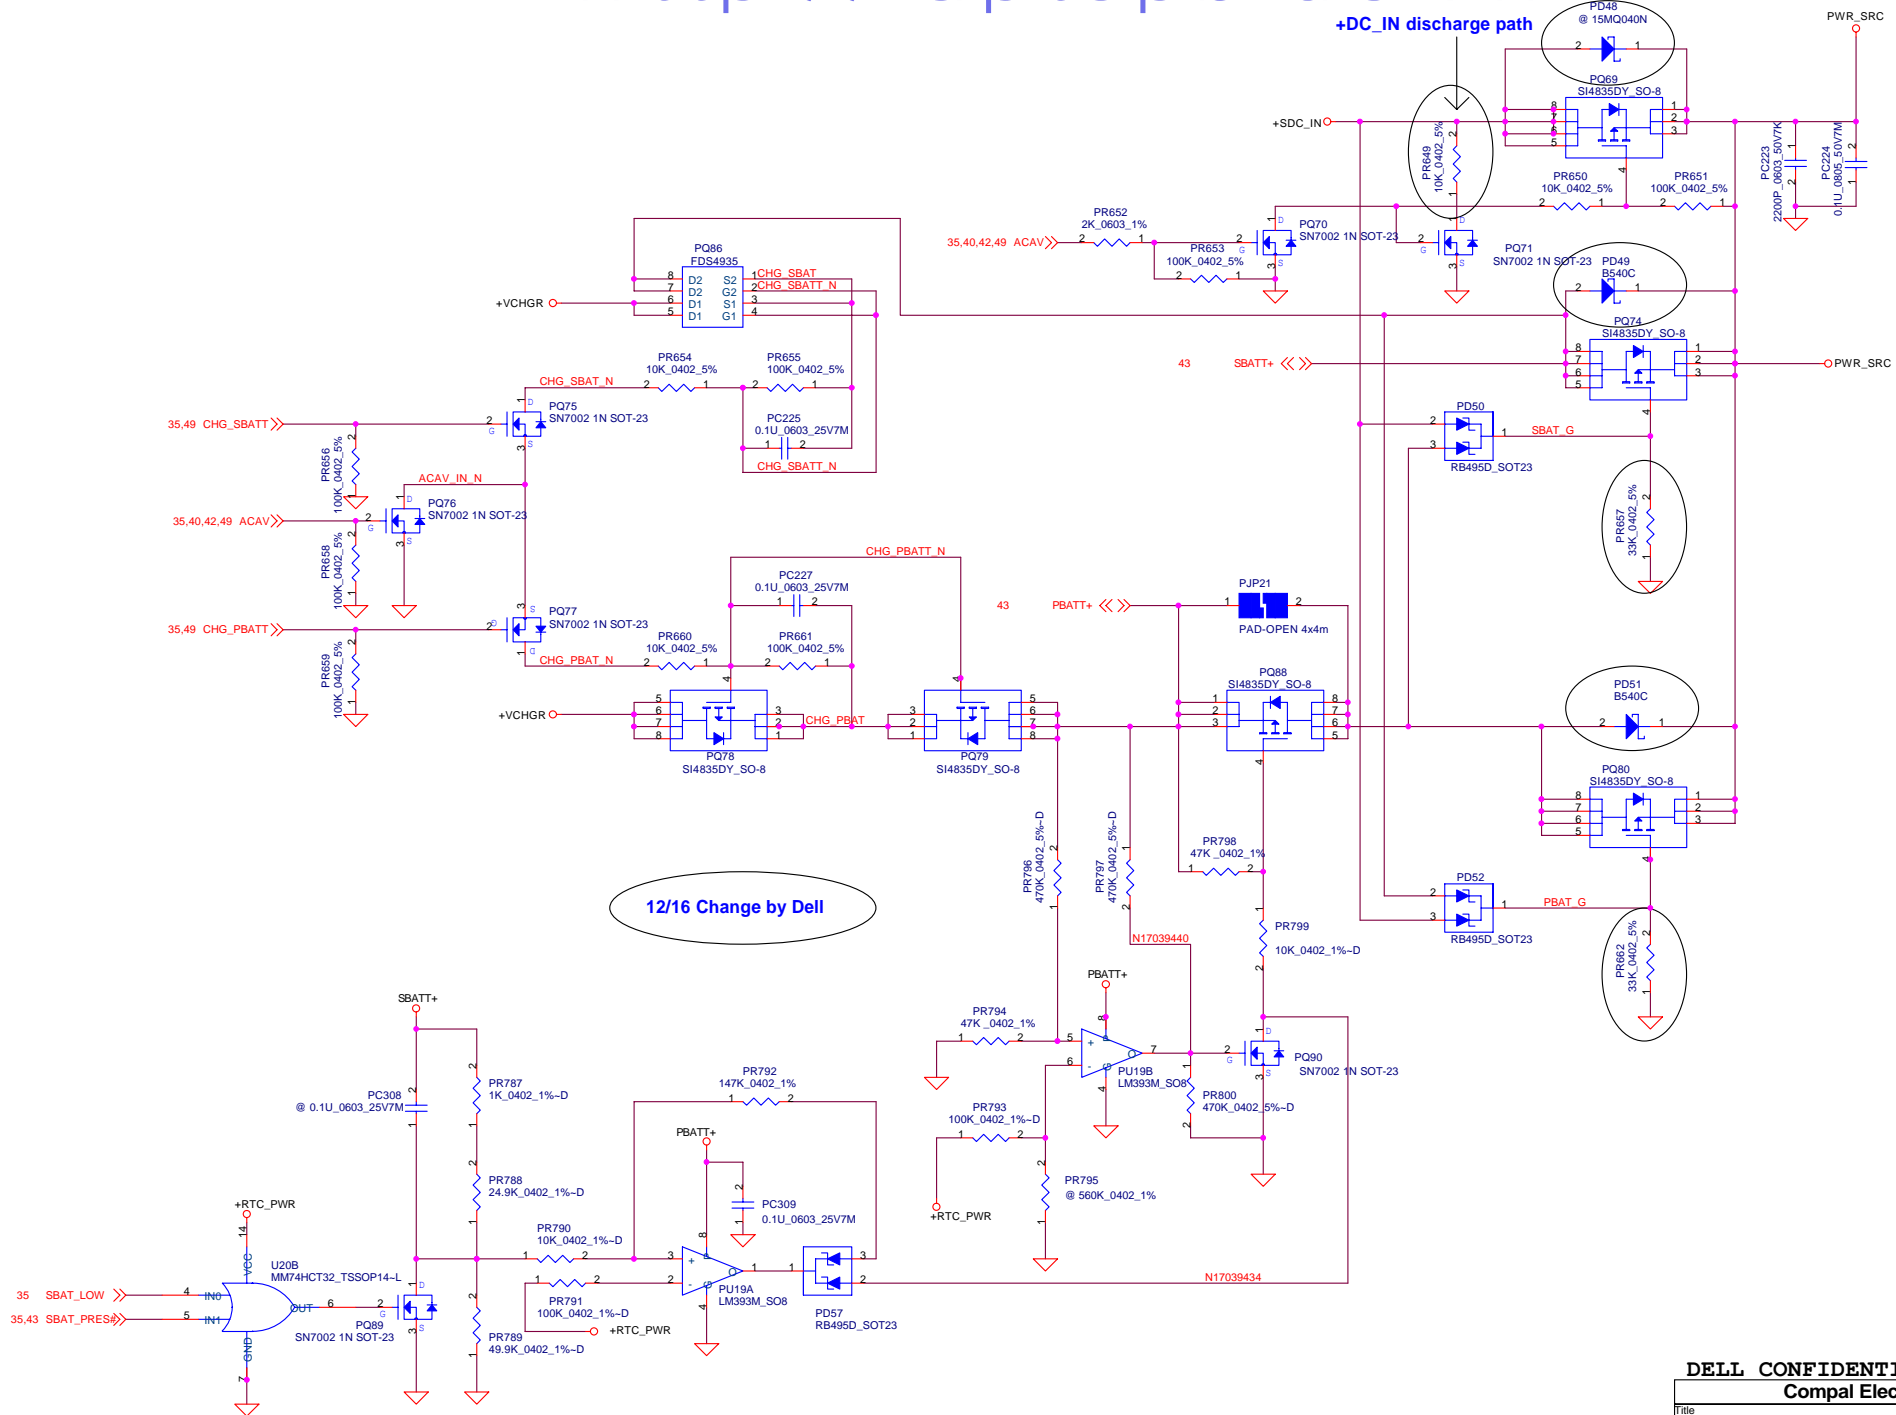
CHARGER CONTROL

65W (2.93A)	90W ( 4.0A )	130W ( 5.85A )
65W	H	L	L
AC_130W_90W	H	L	H
