H800 Main Board1P-0099L00-A000 (COMPEQ)  
1P-0099J00-A000 (IRIS)

TitleINDEX PAGE		
SizeCustom	Document NumberH800 MB	RevX-Build
Date:	Wednesday, October 07, 2009	Sheet1 of 50

# H800 BLOCK DIAGRAM

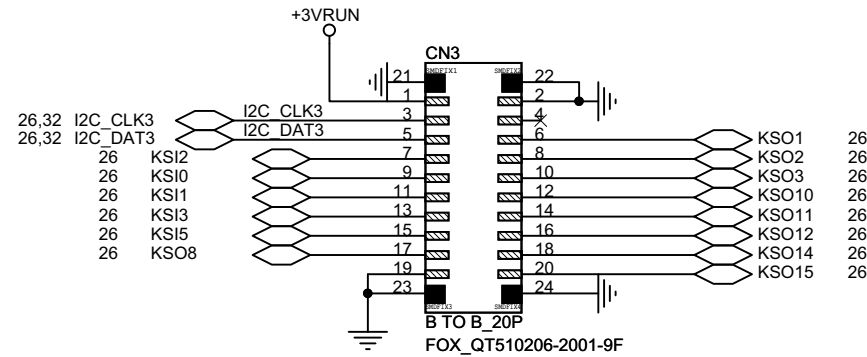
## FUNCTION KEY CONN

Removed on board key pad design
